#### POPPLETON HISTORIC STUDY

MAGI # 0426405411

901 W. Baltimore Street

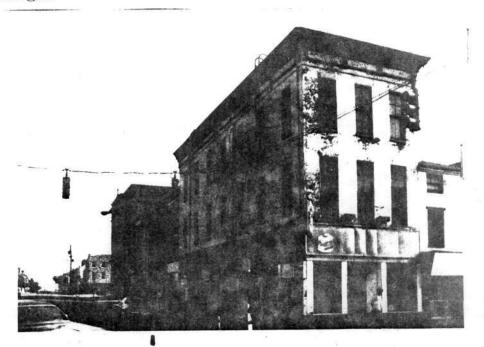
Recommend for rehabilitation as housing above, shop below. This is a pleasantly proportioned building with long, narrow windows set relatively close together. Modern shop front could be removed.

A two story dwelling with attic appears this site 1839-1840. It was presumably replaced by this building as the street grew in commercial importance.

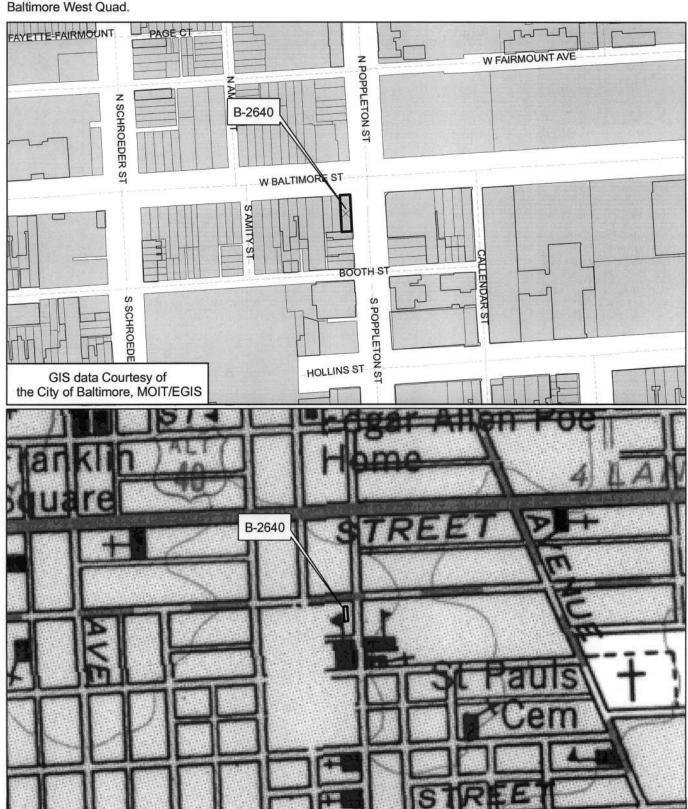
B-2640 901 W. Baltimore Street Block 2 | ¶ Lot 001 Baltimore City Baltimore West Quad.

## **Demolished**
